Manhole Inspection Summary

Manhole # S33Q__053MH

Insp Date: 1/31/08 4:32 PM

Location Address: **unnamed alley**

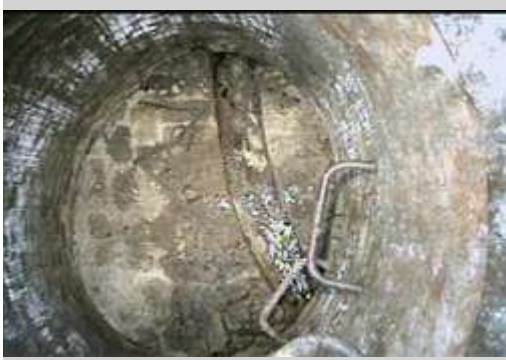
Defect 1

Condition: ☐ Sound ☐ Cracked ☐ Root Intrusion ☐ Deteriorated ☐ Leaks ☒ **Debris**

Bench debris

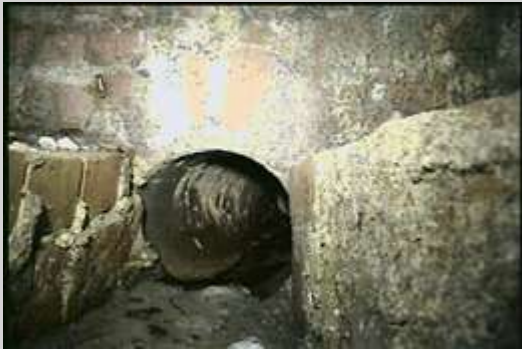
12 O'Clock Outflow

8 in. Circular Gravity Sewer
Pipe Out @ 12 O'Clock

Deposits: ☒ None ☐ Mud ☐ Sludge ☐ Debris ☐ Grease

Infiltration: **None** Pipe Seal Cond: **Unknown**

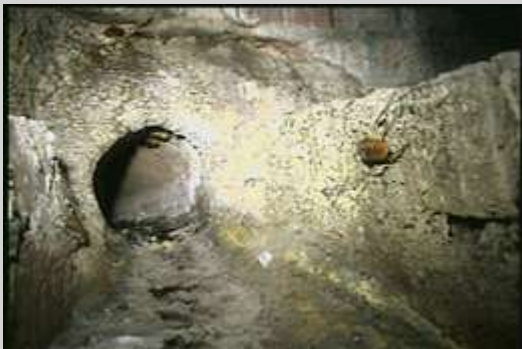
5 O'Clock Inflow

Comments **in pipe is @ 5 only- originally put 7-fyi**

8 in. Circular Gravity Sewer
Pipe In @ 5 O'Clock

Deposits: ☒ None ☐ Mud ☐ Sludge ☐ Debris ☐ Grease

Infiltration: **None** Pipe Seal Cond: **Unknown**
